# Manhole Inspection Summary

Manhole # **S15GG\_012MH**

Insp Date: **2/27/08 11:53 AM**

**Location** Address: **REAR OF 1642 BRADDISH AVE** Cross Street: **PRESBURY ST**

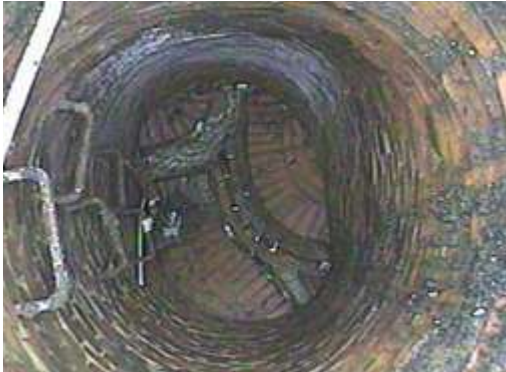
Defect 1

EVIDENCE SURCHARGE

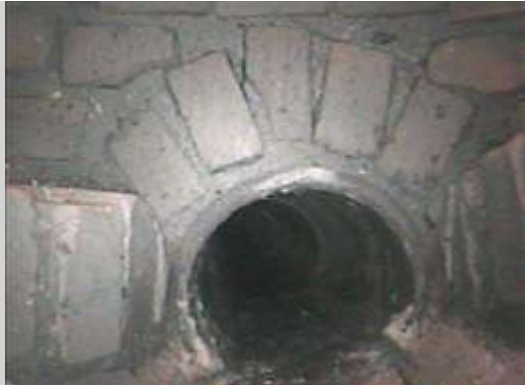
12 O'Clock Outflow

8 in. Circular Gravity Sewer  
Pipe Out @ 1 O'Clock

Pipe Height: (in.) Direct  
Pipe Material: **Clay** ☐ Pipe Lined  
Invert Depth: **13.00** (ft.) Flow Characteristics: **Slow**  
Deposits: ☒ None ☐ Mud ☐ Sludge ☐ Debris ☐ Grease  
Silt Depth: (in.) Deposits Extent:  
Infiltration: **None** Pipe Seal Cond: **Sound**

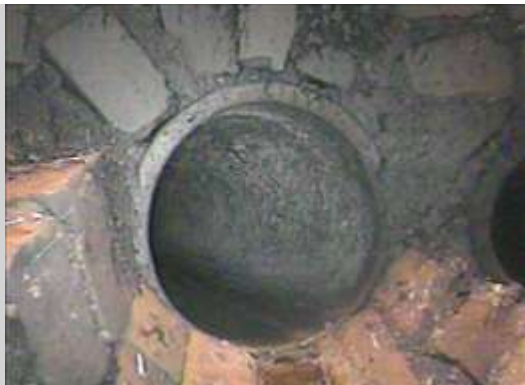
4 O'Clock Inflow

8 in. Circular Gravity Sewer  
Pipe In @ 4 O'Clock

Pipe Height: (in.) Direct  
Pipe Material: **Clay** ☐ Pipe Lined  
Invert Depth: **12.10** (ft.) Flow Characteristics: **Slow**  
Deposits: ☒ None ☐ Mud ☐ Sludge ☐ Debris ☐ Grease  
Silt Depth: (in.) Deposits Extent:  
Infiltration: **None** Pipe Seal Cond: **Sound**

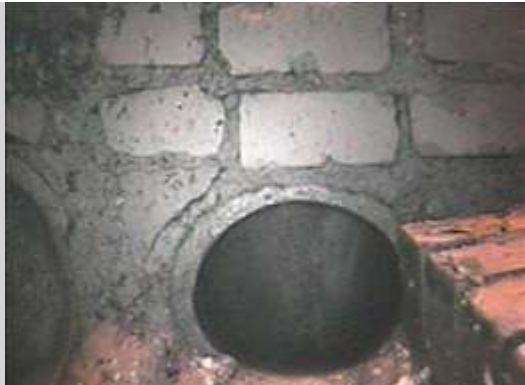
5 O'Clock Inflow

6 in. Circular Gravity Sewer

Pipe In @ 5 O'Clock

Pipe Material: **Clay** ☐ Pipe Lined

Invert Depth: **11.70** (ft.) Flow Characteristics: **Slow**

Infiltration: **None**

Pipe Seal Cond: **Sound**

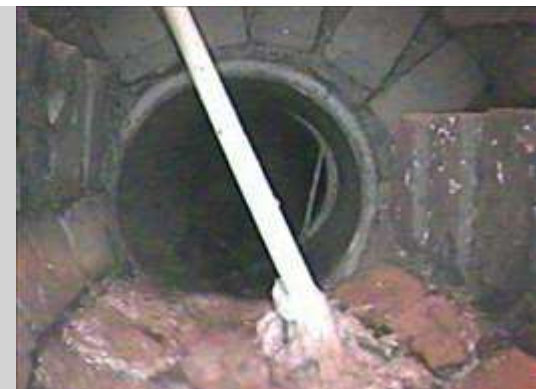
9 O'Clock Inflow

8 in. Circular Gravity Sewer

Pipe In @ 9 O'Clock

Pipe Material: **Clay** ☐ Pipe Lined

Invert Depth: **12.90** (ft.) Flow Characteristics: **Slow**

Infiltration: **None**

Pipe Seal Cond: **Sound**
